Advisory Standards for the Downtown Starkville Historic District

City of Starkville, Mississippi

Carl Small Town Center - 2019
Mississippi State University, Starkville, Mississippi

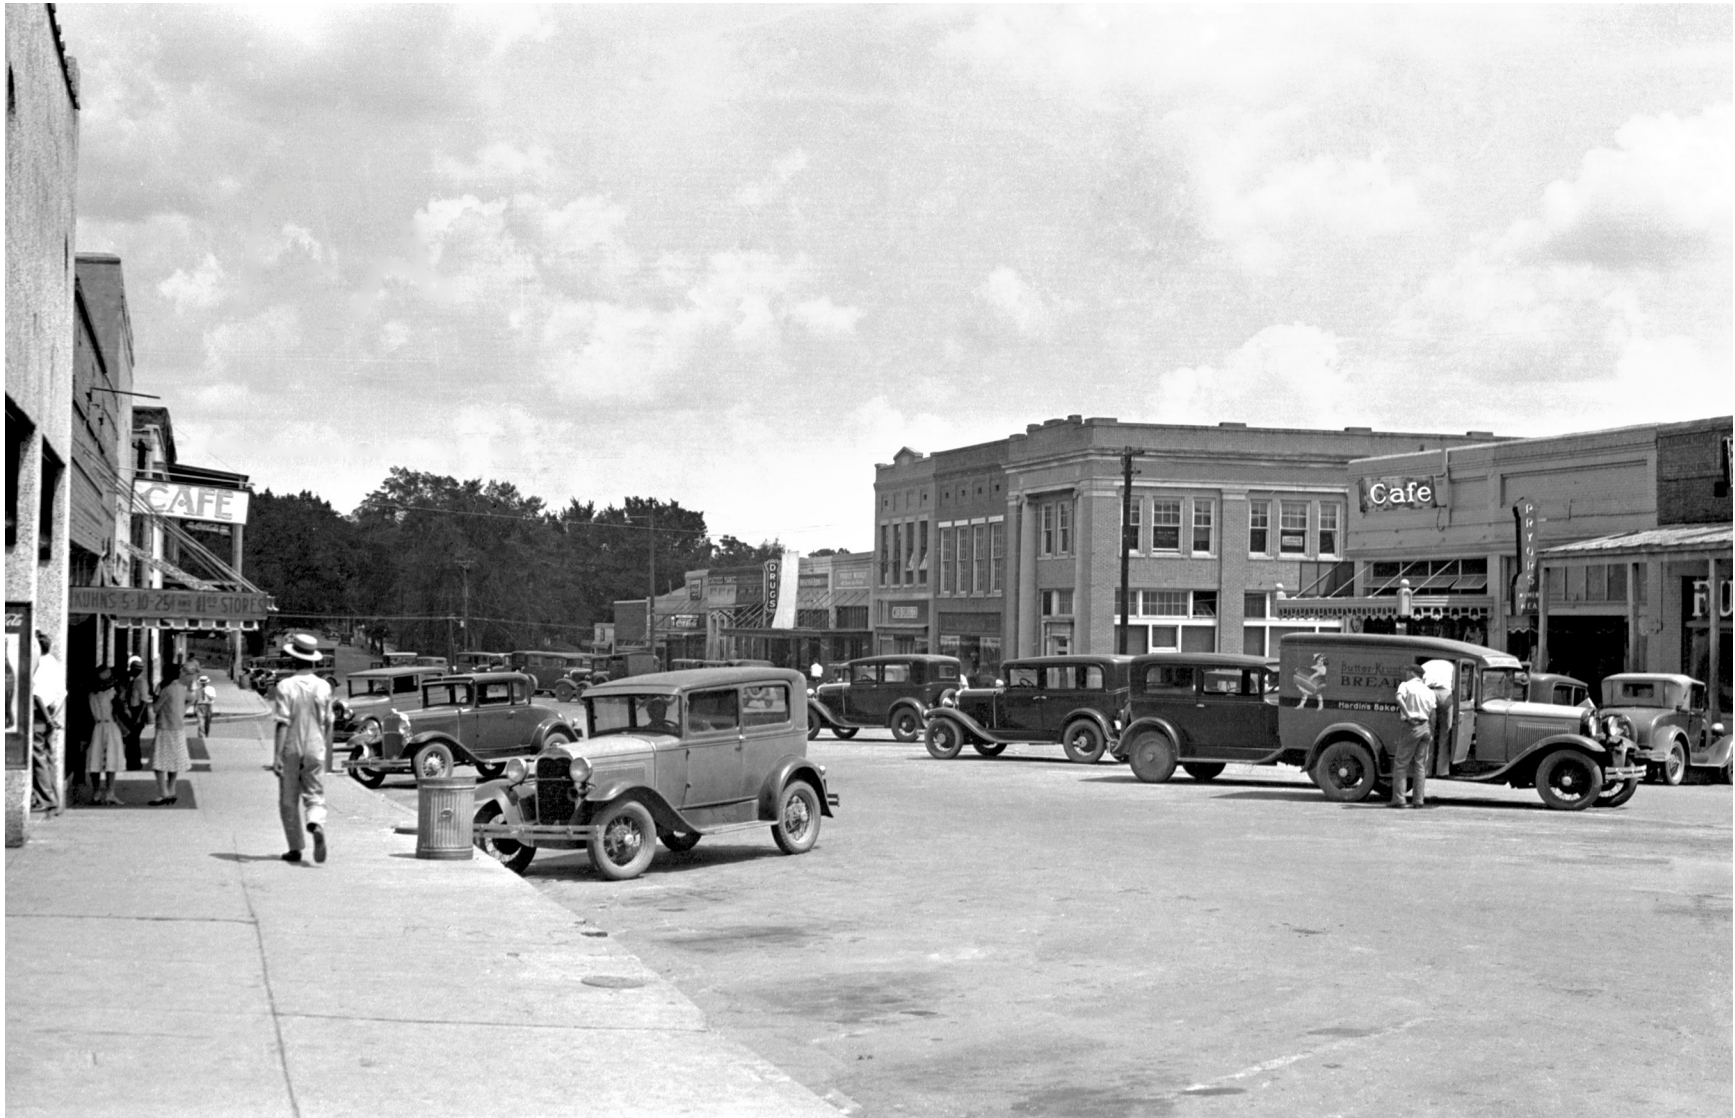
A view of 1920s Starkville looking east on Main Street toward the former Peoples Savings Bank (two stories, with columns) on the corner to the right and Weir Drugstore (one-story, with vertical sign) beyond it.
(University Archives Digital Collections, Mississippi State University)

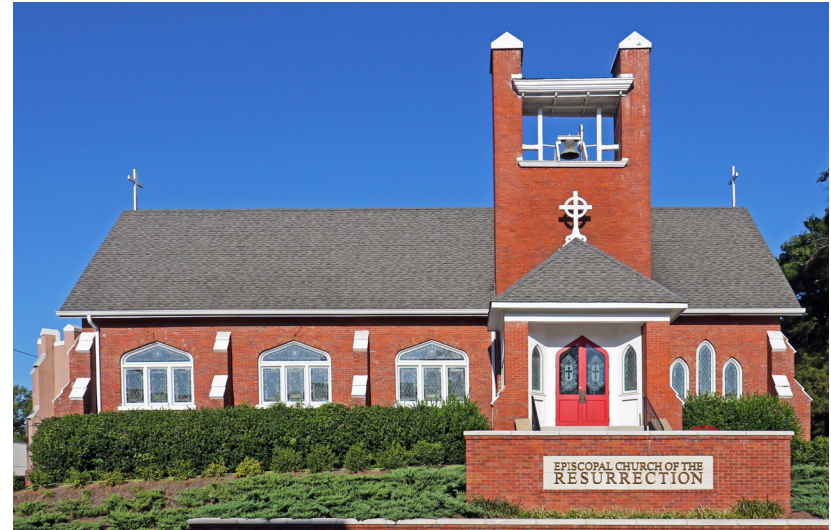
Top photo: The church building at 105 N. Montgomery Street (1913) exhibits the Gothic Revival characteristics of a steeply pitched gable roof, pointed- and Tudor-arch windows, and stained glass.

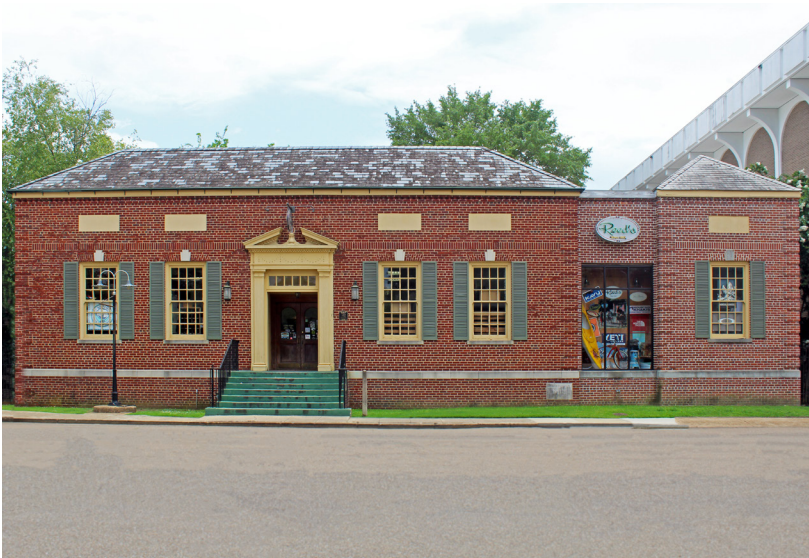
302 University Drive, formerly the U.S. Post Office

Bottom photo: The building at 302 University Drive (1935) features a symmetrical front façade, a hipped roof, a broken pediment, and small-paned windows.

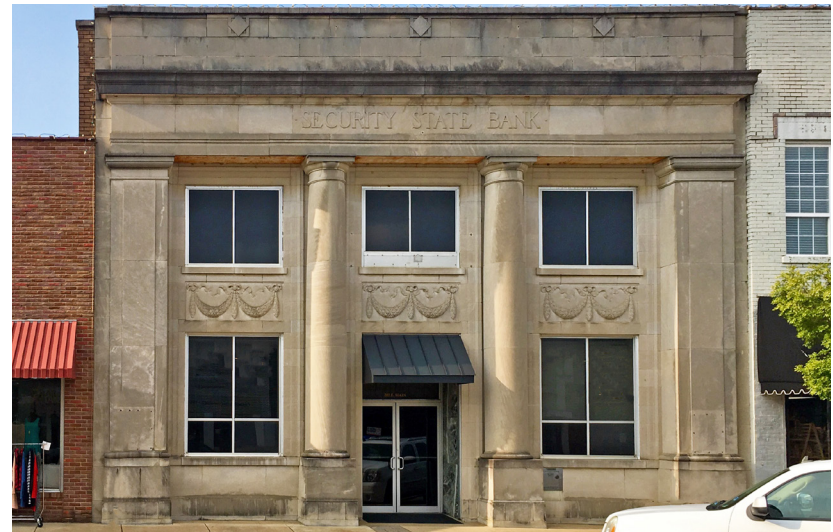
203 E. Main Street

Top photo: The building at 203 E. Main St. (c. 1920) features a symmetrical front façade, stone-masonry construction, a flat roof, and two-story attached columns with antae.

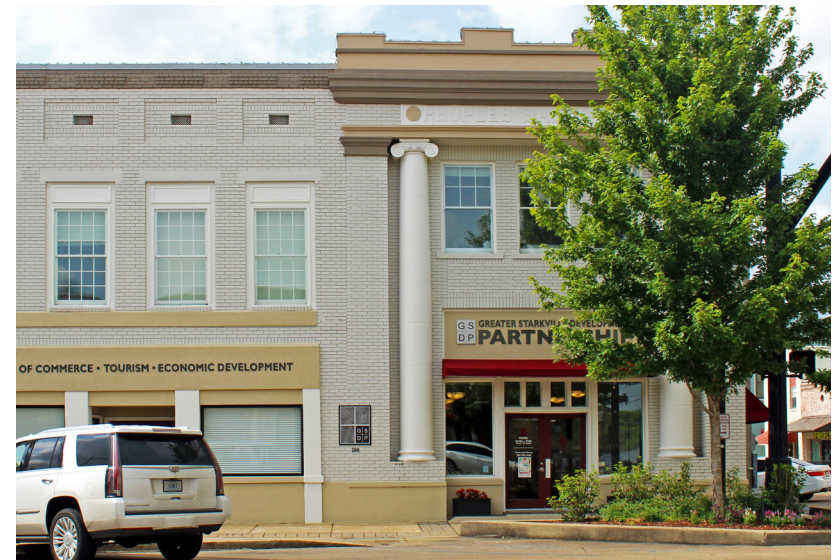
200 E. Main Street

Bottom photo: The building at 200 E. Main St. (1921) now occupied by the Greater Starkville Development Partnership features two-story Ionic columns.

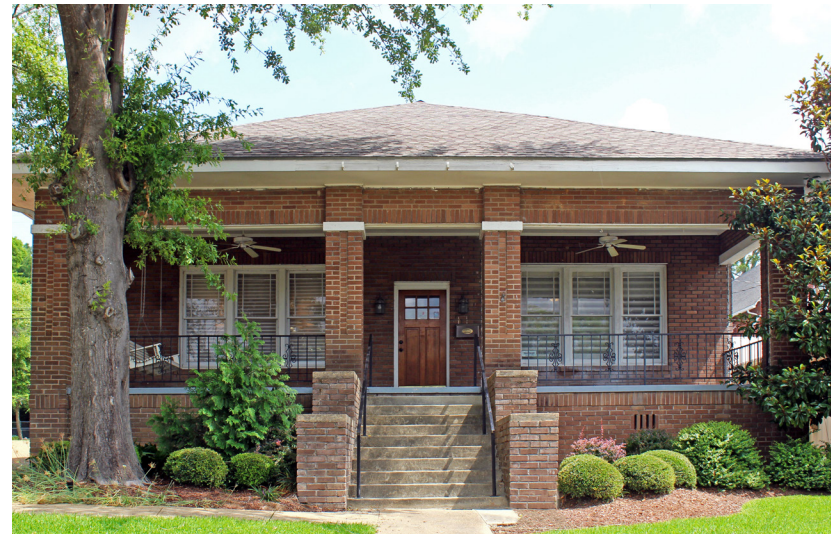
Top photo: The building at 321 University Drive (c. 1930) has a low-pitched hipped roof and an undercut front porch supported by brick piers.

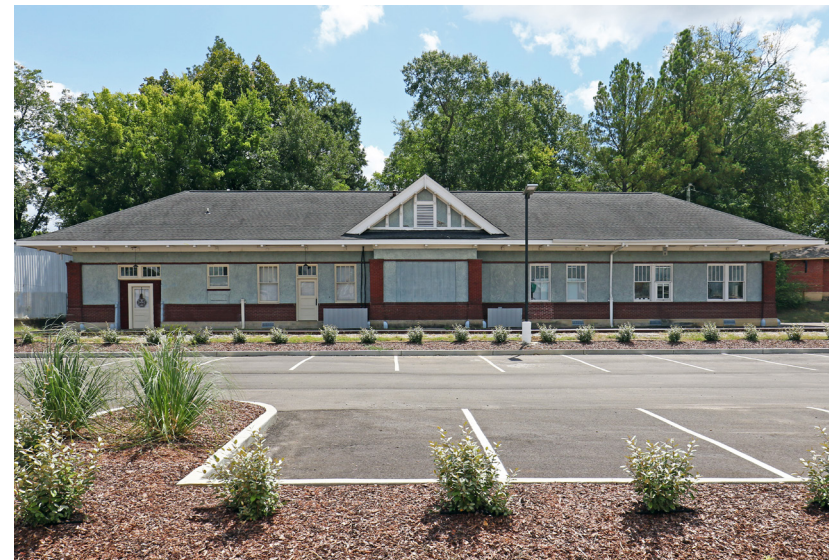
Bottom photo: The historic railroad depot at 223 S. Jackson Street (c. 1915) has a low-pitched hipped roof, deep overhanging eaves, eave brackets, and a gable with false half-timbering

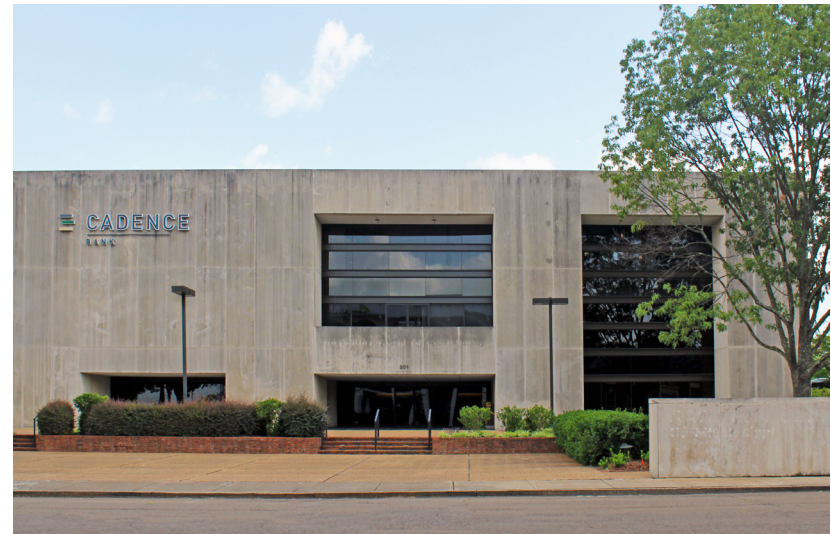
The building at 301 W. Main Street (1977) exemplifies the Brutalist architectural style through its bold massing, raw, unpainted concrete exterior, and unadorned, flat front façade.

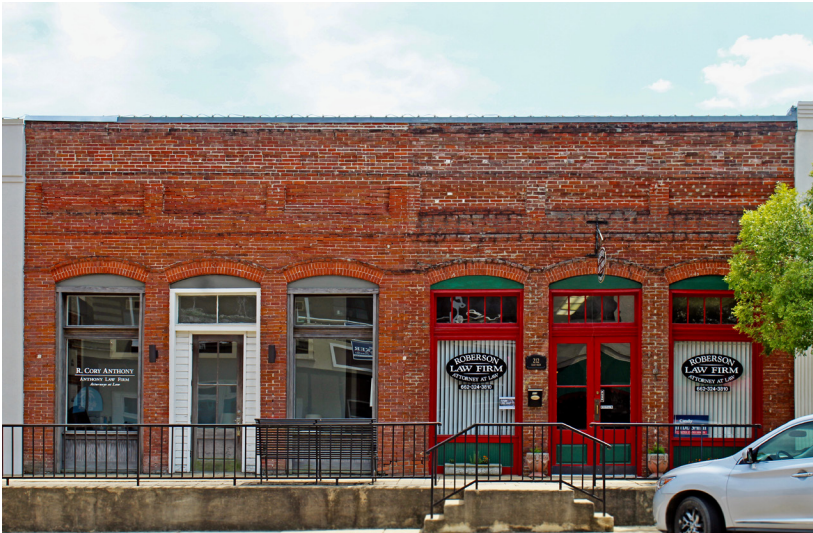
212-214 E. Main Street

Most of Starkville's commercial structures were built in the commercial-vernacular style, almost always in brick. Commercial-vernacular buildings went up in downtowns all across the country, typically without an architect in charge. Instead, they resulted from collective design decisions made over time in many locations and depended on the sensibilities and skills of local craftsmen, particularly brick masons. They feature ground-floor storefronts and may have one story or multiple stories.

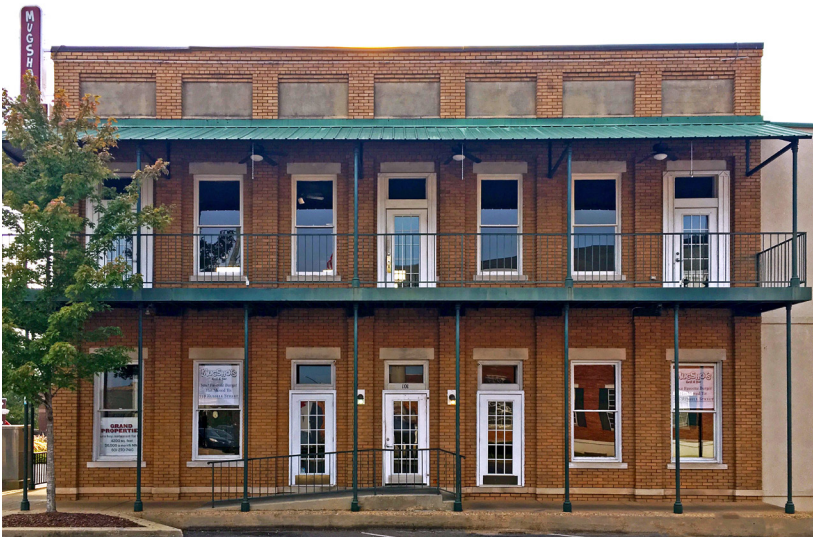
Bottom photo: The brick building located at 100 W. Main Street has a recessed panel parapet and a large number of window and door openings. The two-story gallery is not original to it.

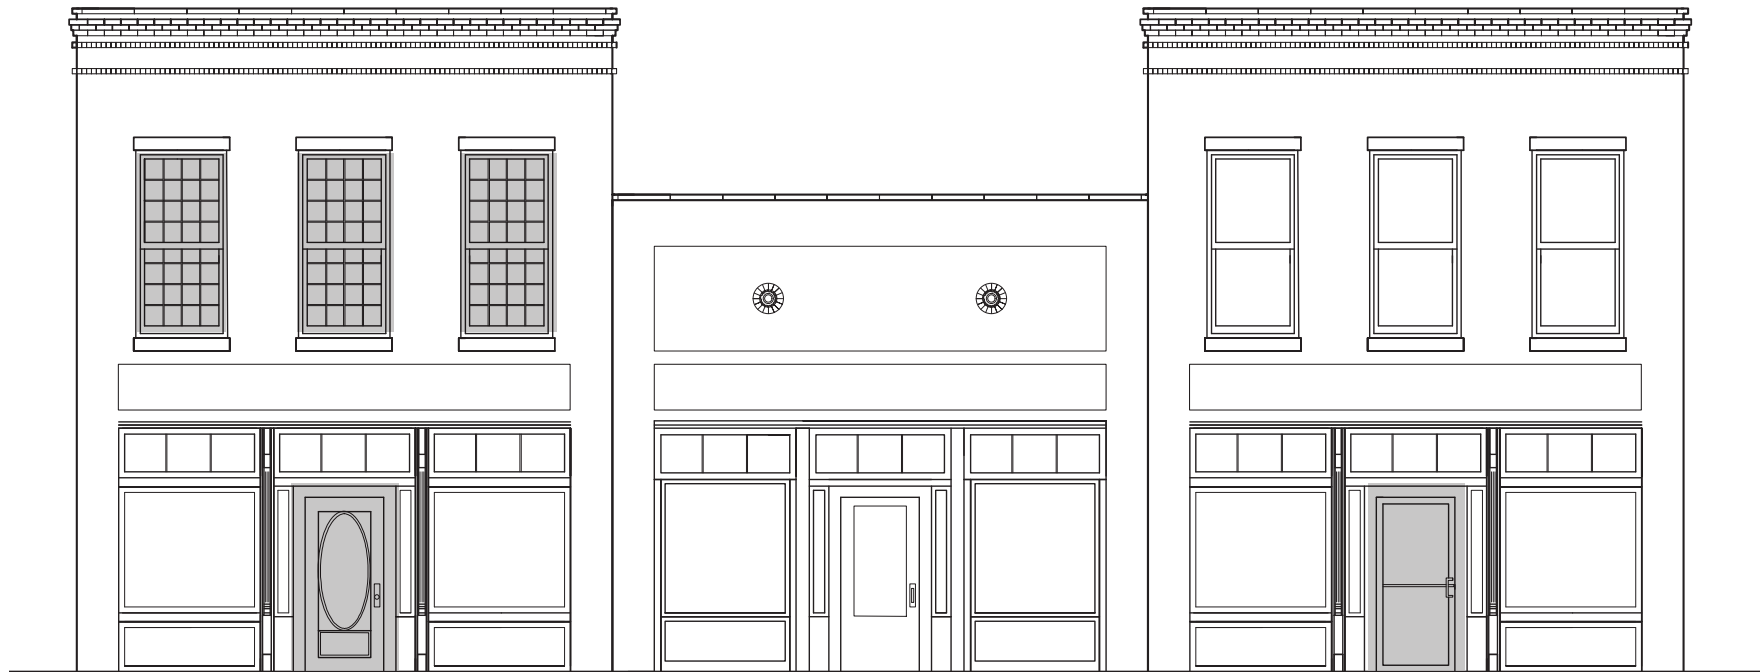
■ Inappropriate Construction

In the facade to the **left**, the windows have been given inappropriate sixteen-over-sixteen sash, and an incompatible door has been inserted.

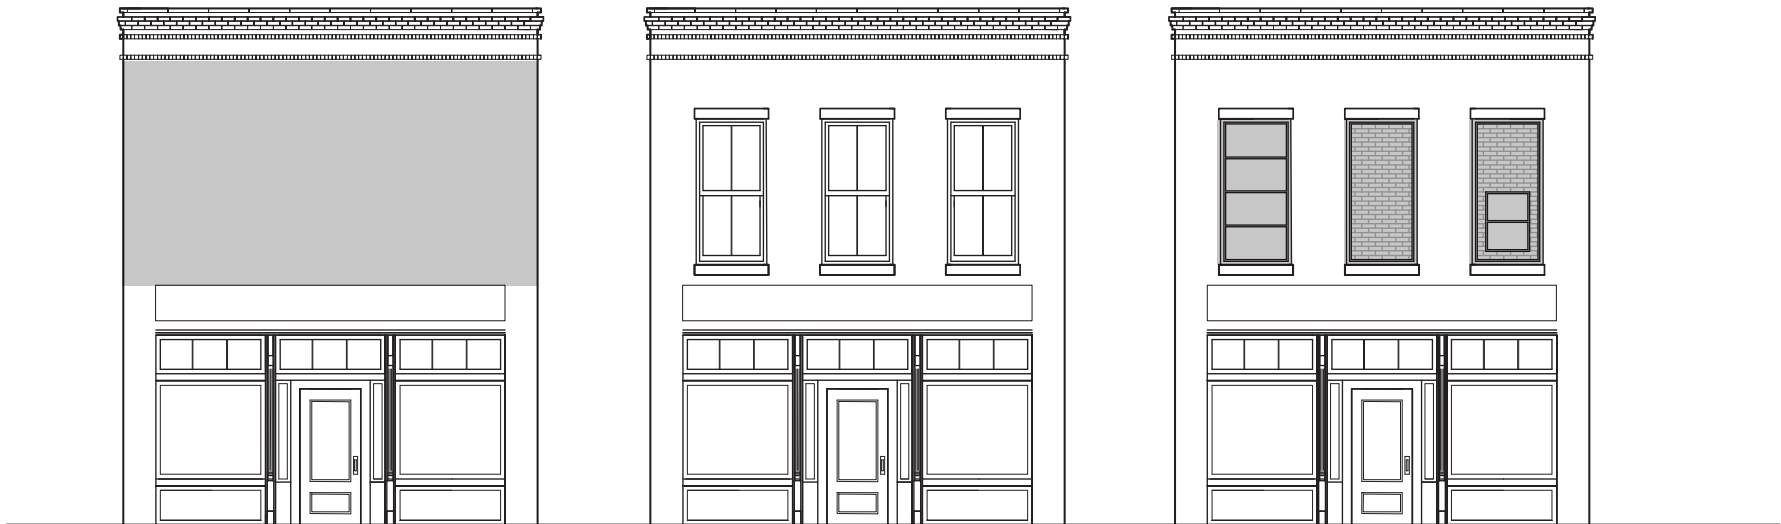
■ Inappropriate Construction

In the facade to the **left**, the windows have been removed, ruining the original proportions and solid-to-void relationships.

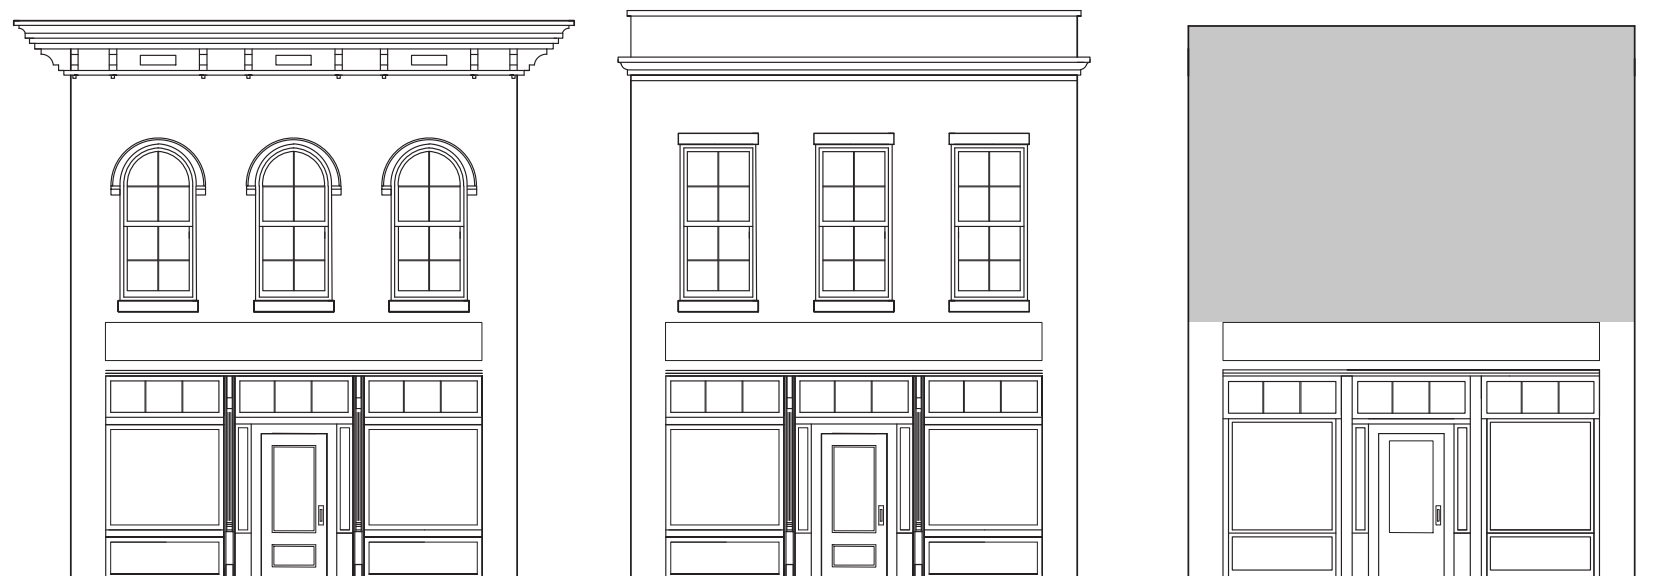
■ Inappropriate Construction

The Italianate facade to the **left** is historically correct, including its deep, bracketed cornice.

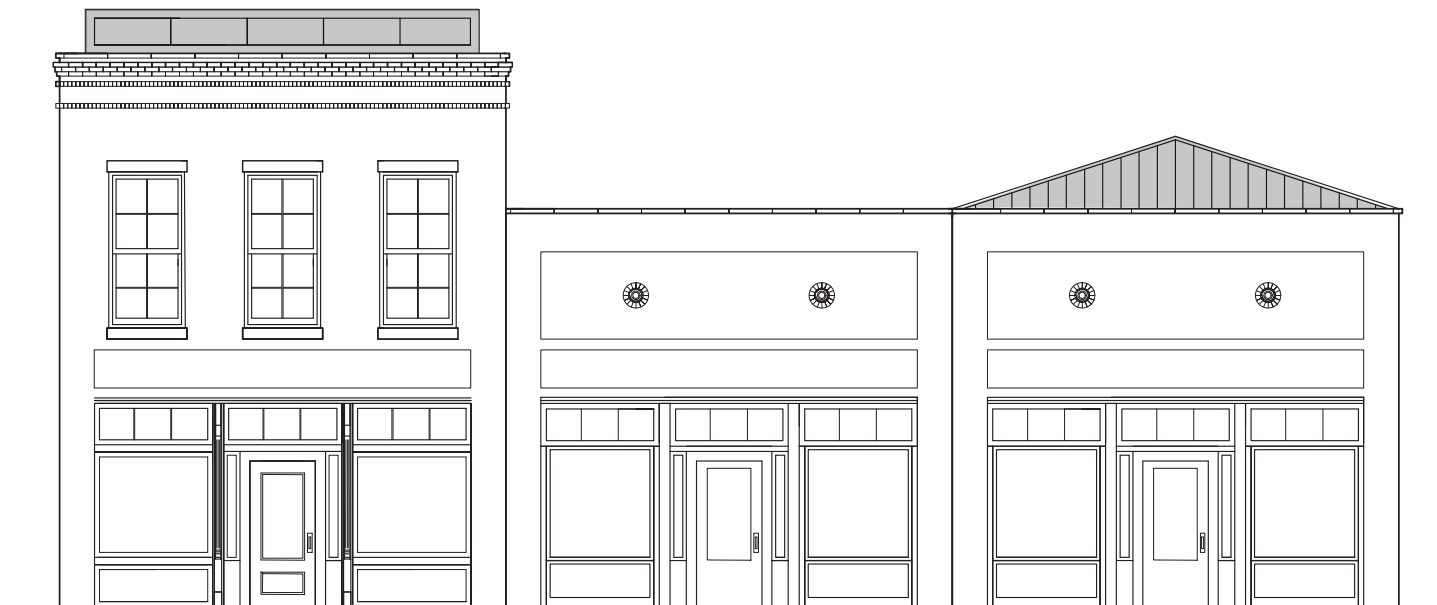
■ Inappropriate Construction

The facade to the **left** is historically correct, but the roof monitor is incompatible.

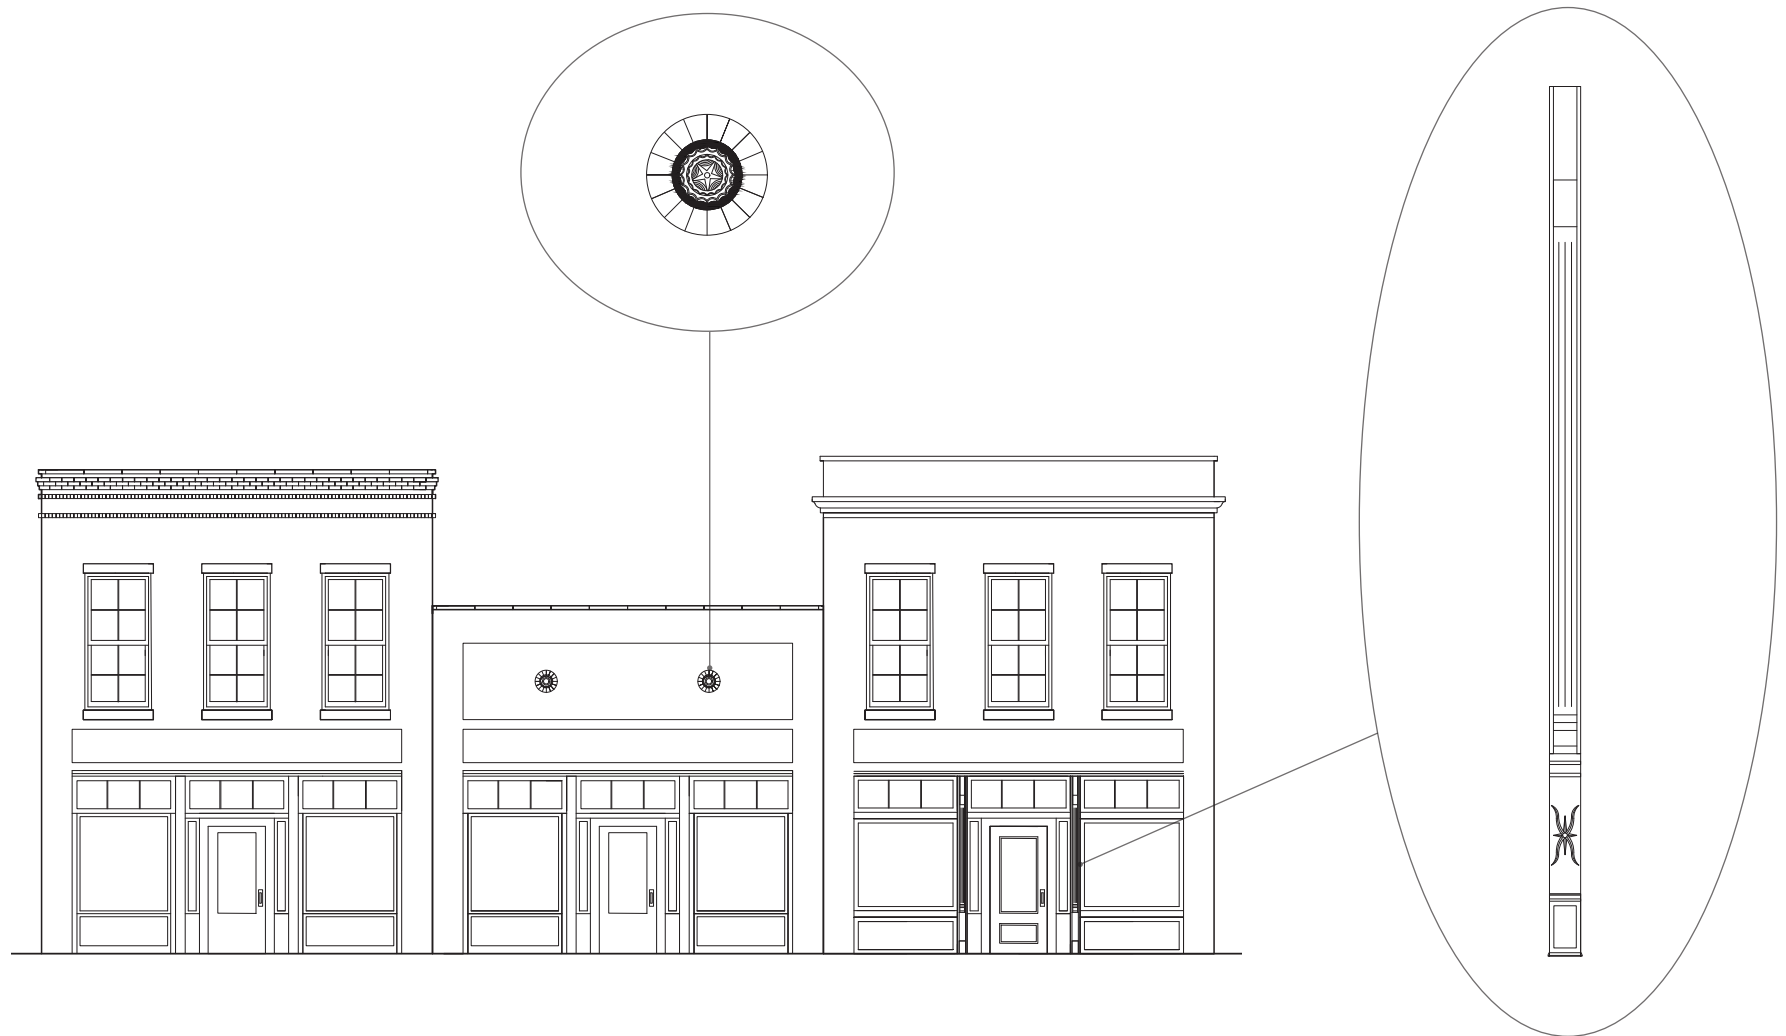
For its architectural character, the facade design to the **left** depends only on basic architectural elements.

In the **center** facade, ventilation grills break up the expanse of the recessed brick panel.

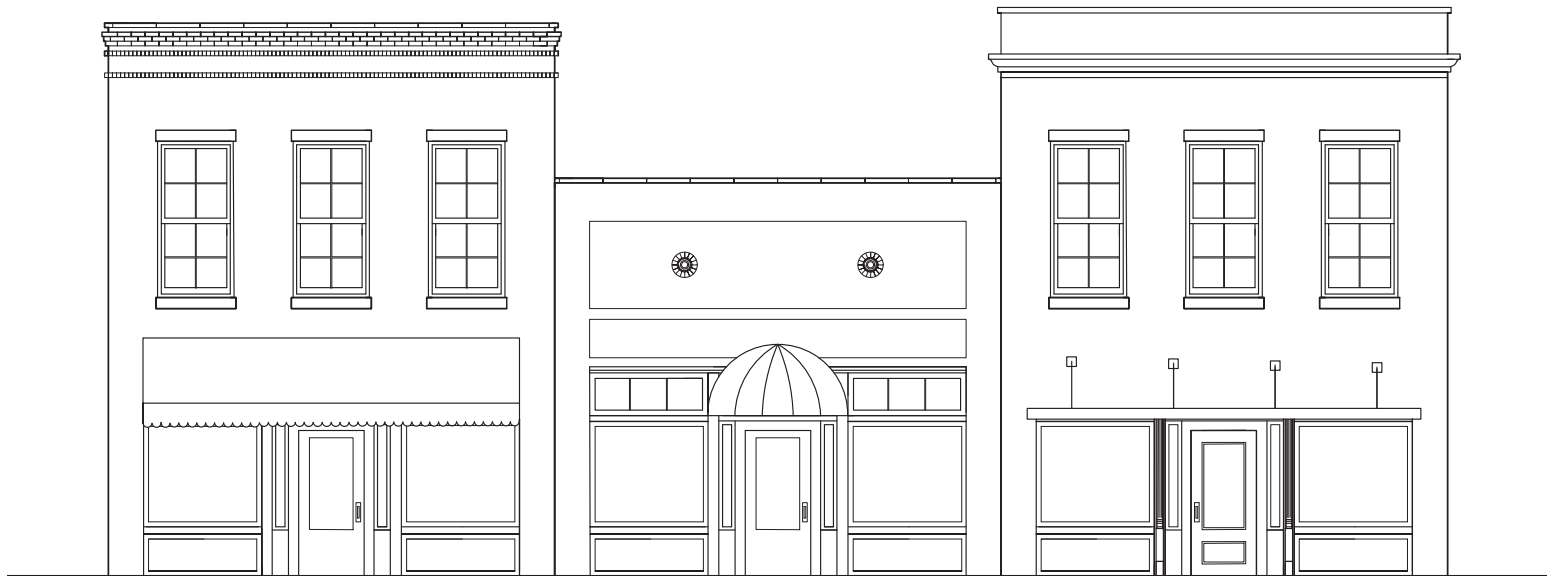
The buildings at the **left** and in the **center** have appropriate fabric awnings.

The building to the **right** has an appropriate metal canopy.
